# TEST REPORT

Sample name: All-in-one solar charge inverter  
Model No./ Material: HF2430U60-100  
Number of sample: 1pc  
Sample Received: 2021-04-23  
Testing Period: 2021-04-23

**Test item:** Drop test  
**Test standard:** According to client's requirements and refer to the standard ISTA-1A 2001

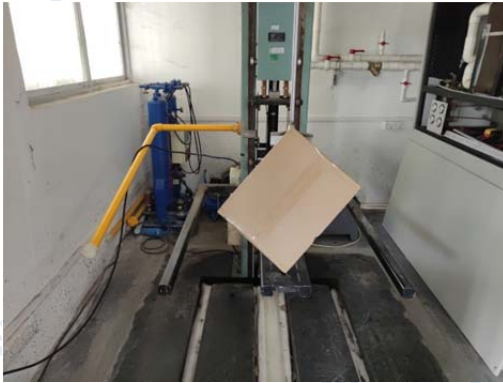
<p>Before test-3</p>	<p>Testing-1 (corner)</p>

- 1) Sample test status: packaged.
- 2) Drop height: 760mm.
- 3) Drop position: 1 corner, 3 edges, 6 face.
- 4) Drop times: 1 times/position.
- 5) Drop floor: Steel plate.
